DelValley Home Inspections LLC

CONFIDENTIAL INSPECTION REPORT

3465 Kent St, Wilmington, DE. 19805

6/2/2006 8:30 am to 11:00 am

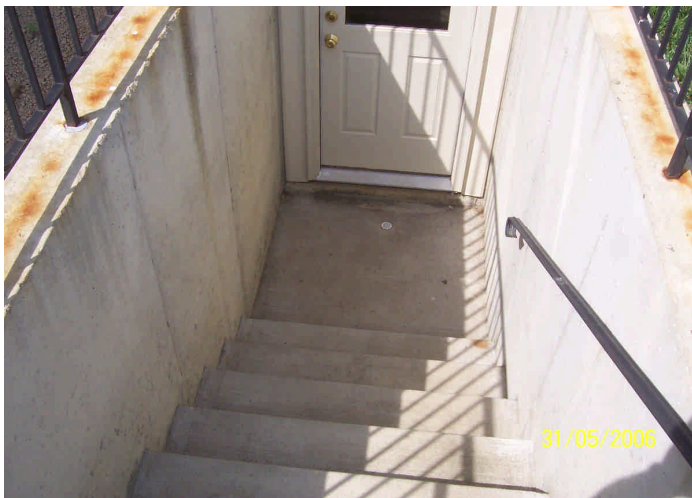
The drain at the bottom of the exterior steps should be cleaned too allow for good drainage

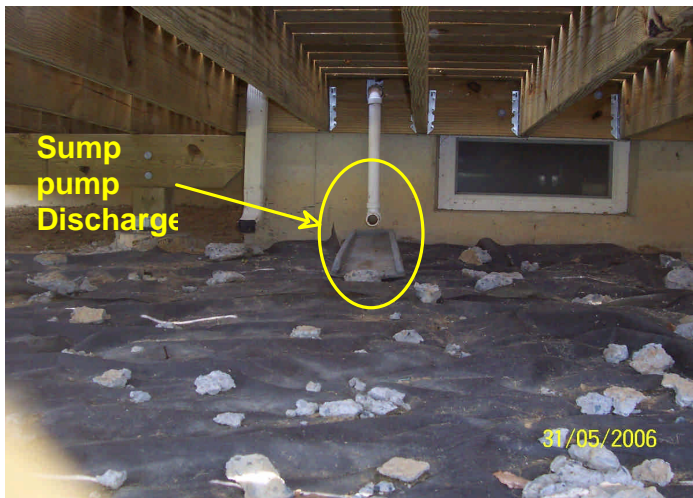
An extension should be added to the sump pump discharge pipe to prevent erosion.

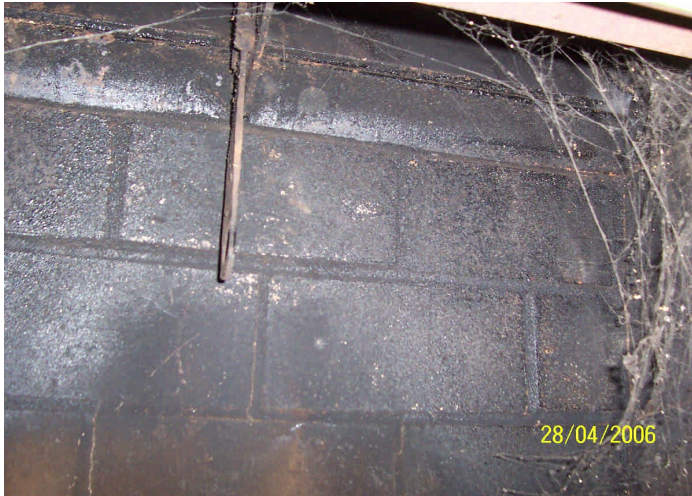
Heavy creosote buildup visible in the flue. The fire place is unsafe to use until it is fully cleaned and serviced by a qualified contractor.

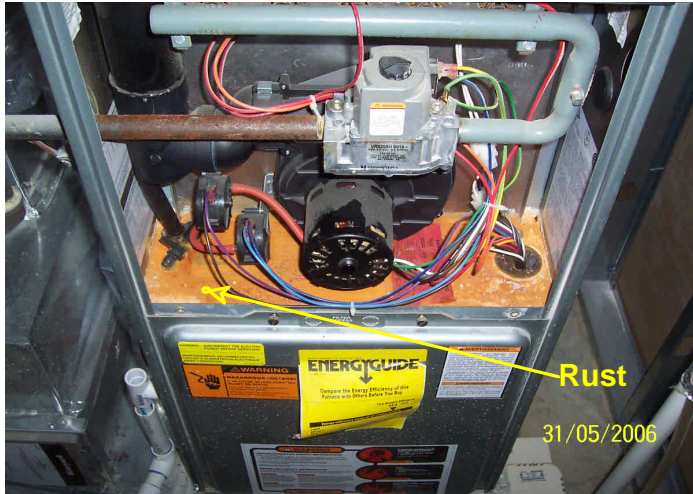
Evidence of a condensate leak noted in the unit but appears to have been repaired

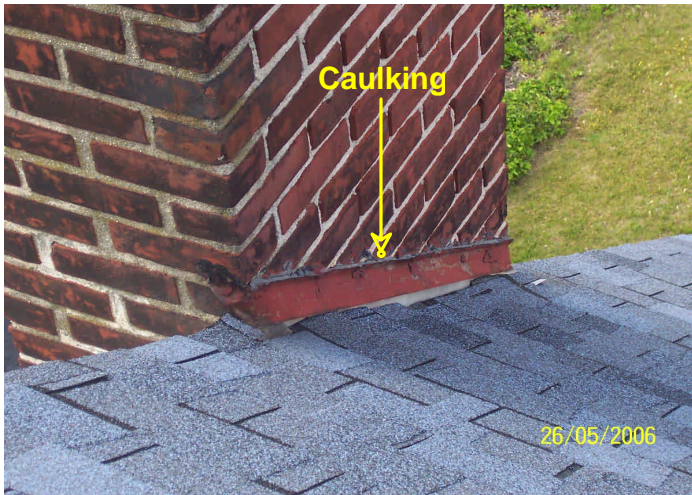
Flush mounted flashing noted on chimney. Flashing fastened directly to the face of the chimney relies entirely on caulk to maintain a watertight joint. In time the caulk will fail allowing water to penetrate the house. This flashing condition must be maintained on a regular bases to prevent leaks.
